**TECHNICAL MEMORANDUM**

Reference No. 19130795-045-TM-Rev0

# AKZO NOBEL SUNSHINE NORTH – DECEMBER 2021 BOUNDARY AND RESIDENTIAL ODOUR MONITORING RESULTS.

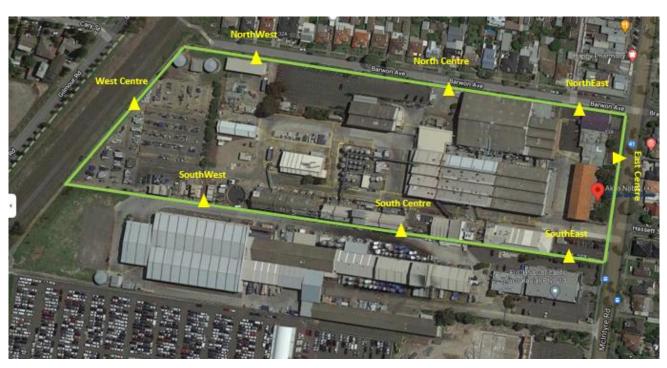
Each boundary odour assessment was undertaken on foot while walking the entire site perimeter, inside the boundary line fence. On occasion, facility operations or mobile plant being used on the Site may require a minor deviation from the usual boundary assessment route. The boundary odour monitoring route is presented in Figure 1.

Figure 1: Boundary odour monitoring route

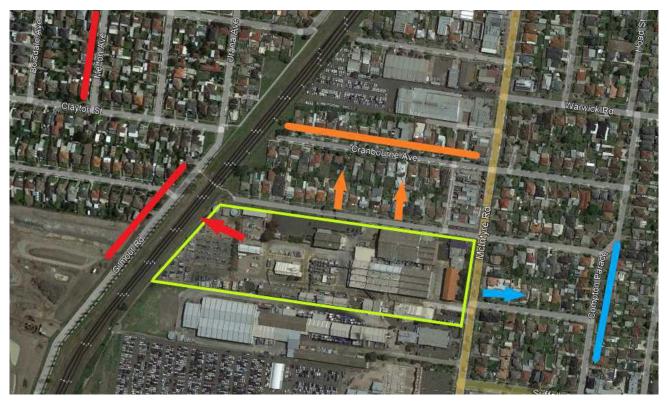
The residential odour assessment was undertaken when an odour intensity of three or higher was recorded along the north, east or west boundary of the AkoNobel site. Residential odour assessments are conducted parallel and downwind from the site boundary at four evenly spaced locations (where possible) in the residential area. Example routes for residential odour monitoring are presented in Figure 2. Actual monitoring locations will vary based on wind speed and direction.

Figure 2: Residential odour monitoring locations
