TECHNICAL MEMORANDUM

Project No. 19130795-041-TM-Rev0

AKZO NOBEL SUNSHINE NORTH – NOVEMBER 2021 BOUNDARY AND RESIDENTIAL ODOUR MONITORING RESULTS.

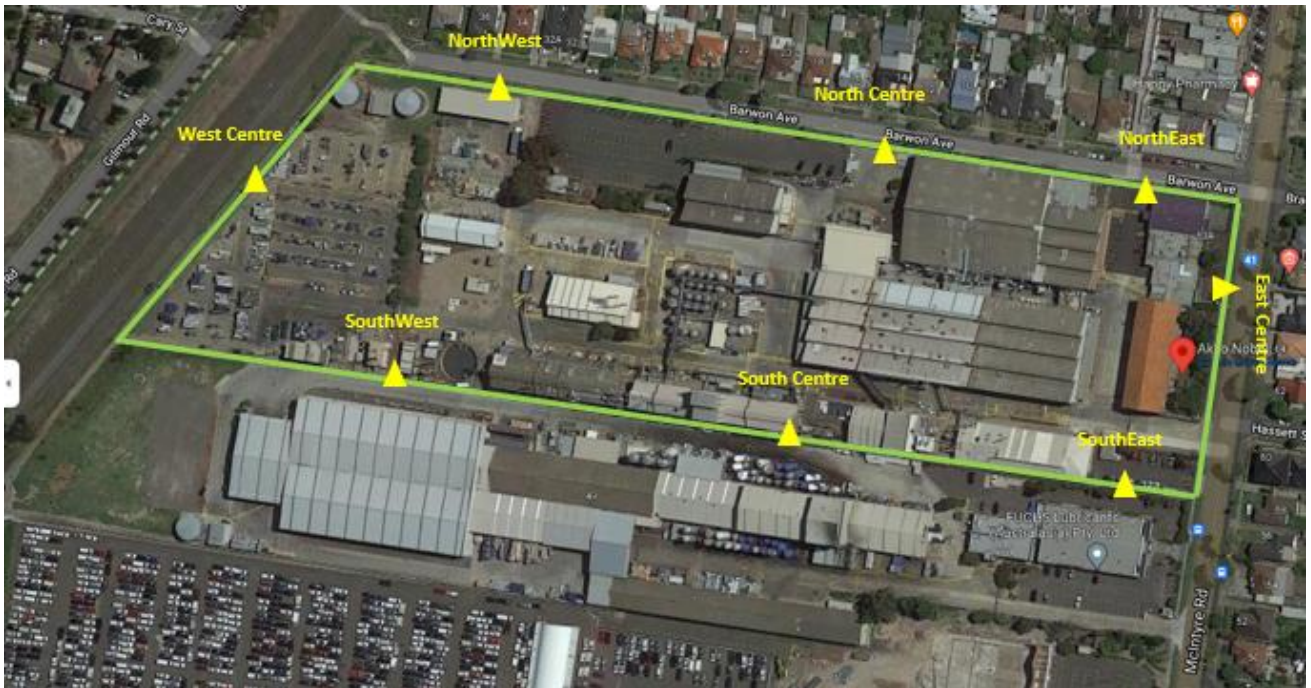
Each boundary odour assessment was undertaken on foot while walking the entire site perimeter, inside the boundary line fence. On occasion, facility operations or mobile plant being used on the Site may require a minor deviation from the usual boundary assessment route. The boundary odour monitoring route is presented in Figure 1.

Figure 1 Boundary odour monitoring route

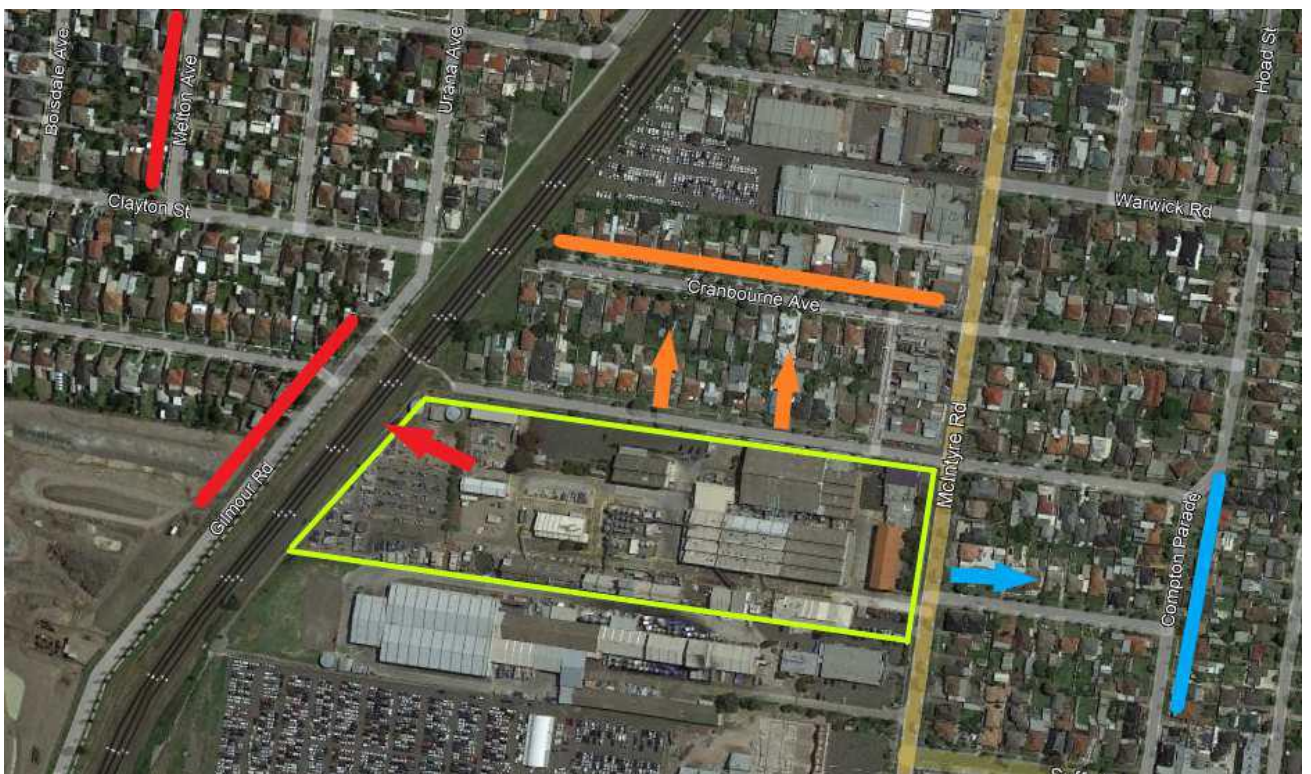
The residential odour assessment was undertaken when an odour intensity of three or higher was recorded along the north, east or west boundary of the AkoNobel site. Residential odour assessments are conducted parallel and downwind from the site boundary at four evenly spaced locations (where possible) in the residential area. Example routes for residential odour monitoring are presented in Figure 2. Actual monitoring locations will vary based on wind speed and direction.

Figure 2: Residential odour monitoring locations
